Manhole Inspection Summary

Manhole # S35M__037MH

Insp Date: **3/24/08 9:06 AM**

Location Address: **600 light st**

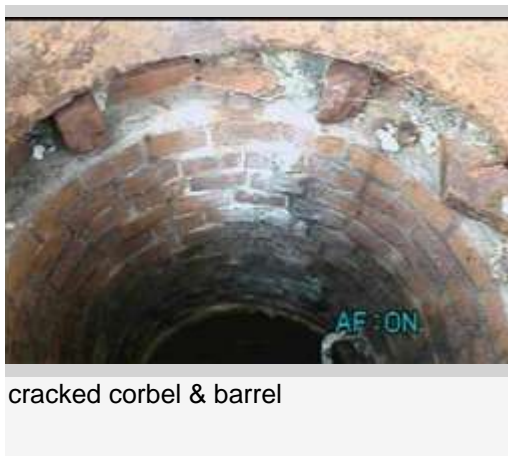
Defect 4

☒ **Cracked**

cracked corbel & barrel

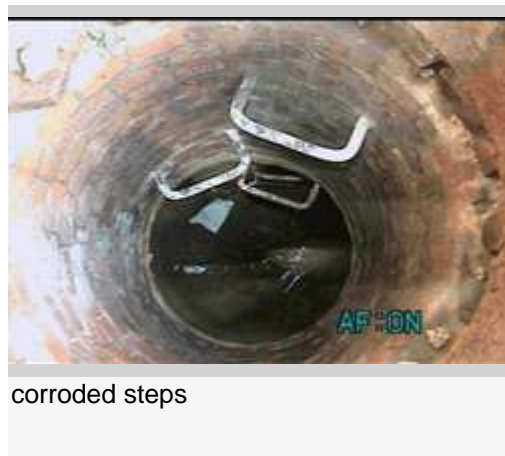
Defect 3

☒ **Corroded**

corroded steps

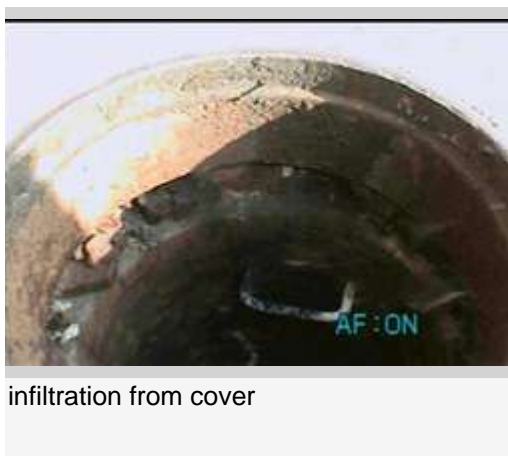
Defect 2

☒ **Leaks**

infiltration from cover

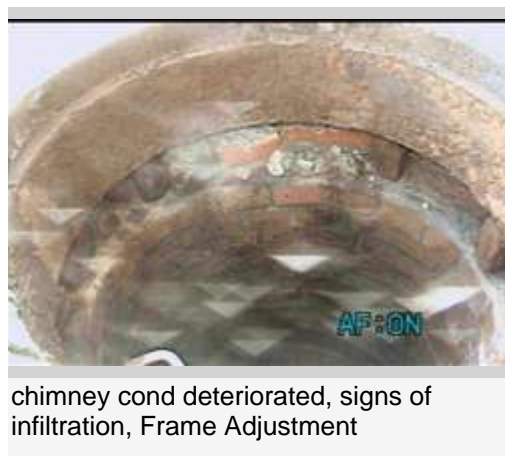
Defect 1

☒ **Deteriorated**

☒ **Joint**

chimney cond deteriorated, signs of infiltration, Frame Adjustment
